East Sutton Parish Council

**EN1176 Level Three Annual Safety
Inspection of
External Fixed Play & Sports Equipment**

July 2020

- Outside play area, Church lane, East Sutton

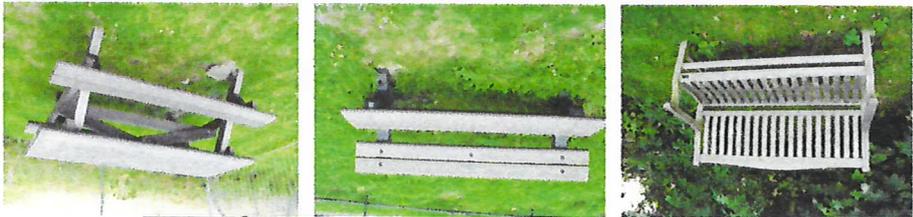
Other Site Auxiliary Items

The bench seating and picnic bench were complete and secure

- The litterbin was complete and secure.
- The stile in the corner of the rear boundary was in very poor condition, with missing parts and the remaining ground posts were loose in the ground fixings. Debris was also found across the access path leading to the adjacent farmers field, causing a potential trip hazard to walkers using this a public foot path. It is recommended that the existing remains of the stile are removed, the path cleared and consideration given to the construction of a new stile.

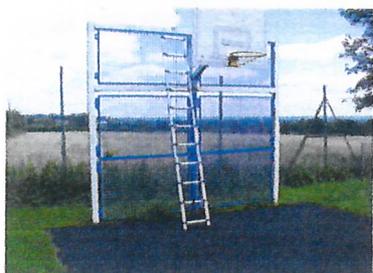
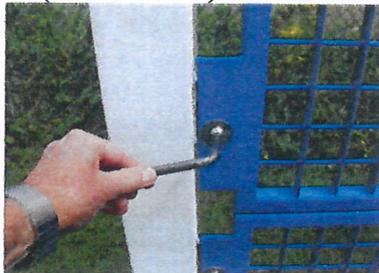
Fixed Play & Sports Equipment
Unit One: Metal Mesh Back Panel with Basket Ball Ring

- The rubber crumb surface including kerb edging was complete, level and compliant to the relevant sections of the EN 1176-1:2008 & BS594987:2010 safety standards

- The metal box section posts and cross frame members were complete and secure.
- The six metal mesh panels were complete and secure.

- The moulded plastic basketball backboard and attached metal ring were complete and made secure during the inspection.
- All fixings were complete and made secure
- Painted & galvanised surfaces were in an acceptable condition with no notable surface heavy corrosion

- At the time of the inspection this unit of equipment was in an acceptable condition and compliant with the relevant sections of the EN 1176-1:2008 safety standards and BS EN 14904:2005 (basket ball) standards.

Carryout maintenance as recommended by the manufacture.

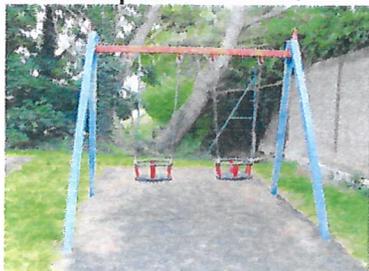
Unit Two : Single Bay of Two Cradle Swings

- The rubber crumb impact absorbing surface has a minimum depth of 45mm and is compliant to the EN 1176 safety standards. The inspection noted a build up of surface leaf debris

- The box section metal swing frame and overhead cross beam were complete and secure
- The swing seat chains and connecting shackles were complete and secure. Wear in the overhead shackle points was within acceptable levels. The cradle swing seats were complete and secure with seat height of 520mm.
- All fixings were complete and secure and painted surfaces were in an acceptable condition with no notable surface corrosion

- At the time of the inspection this unit of equipment was in an acceptable condition and compliant with the EN 1176-1:2008 & 1176-2 (swings) safety standards.

- Remove the build up of debris from the rubber crumb surface

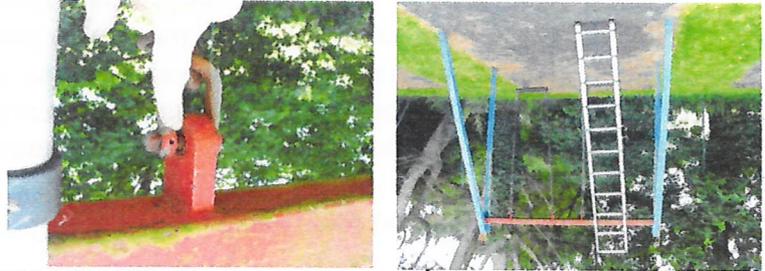
Unit Three: Single Bay of Two Adult Swings

- The swing seat chains and connecting shackles were complete and secure. Some wear was noted in the chain shackle bearings. However The inspection noted excess wear in one of the bearings (see photo).

- The swing seats were complete and made secure during the inspection. Swing seat height measured at 540mm and finger probe test confirmed the chains met the EN1176 standards

- At the time of the inspection this unit of equipment was in an acceptable condition and compliant with the EN 1176-1:2008 & 1176-2 (swings) safety standards.

- Monitor the worn swing shackle bearing and consider its replacement in the next 6 to 12 months to reduce wear to other parts
- Remove the build up of debris from the rubber crumb surface.

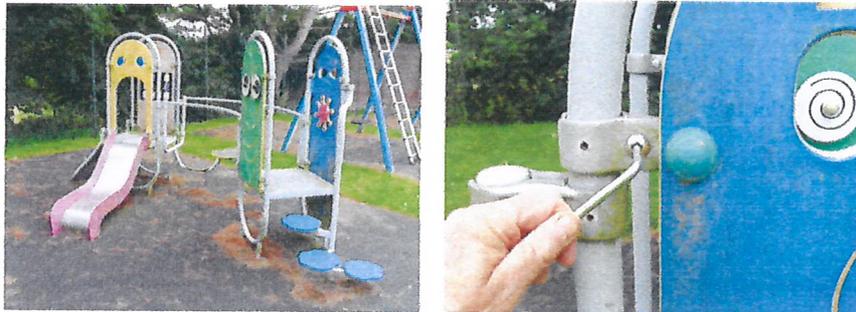
Unit Four: Multi Play Frame

- The metal ground support posts and associated metal frame members were complete and secure.

- The two metal platforms were complete and secure
- Angled metal & plastic ramp with foot blocks were complete and secure
- Metal slide was complete and secure
- The three moulded plastic access steps and frame were complete and secure
- The four moulded plastic bridge step pads and associated frame & side metal rails were complete and secure
- The four moulded plastic platform barrier panels were complete secure and attached puzzle / game parts were in working order
- All fixings were complete and secure
- Painted & galvanised surfaces were in an acceptable condition with no notable surface corrosion

- At the time of the inspection this unit of equipment was in an acceptable condition and compliant with the EN 1176-1:2008 & 1176-3 : 1998(slides) safety standards.

- Remove the build up of debris from the rubber crumb surface.
- During the proposed wash down of the equipment before opening the site consider scrubbing off the build up of surface green algae.
